LTB01238NAS2

# TECHNICAL BULLETIN

'Smart key not found' Message Displayed and Poor Smart key Operation

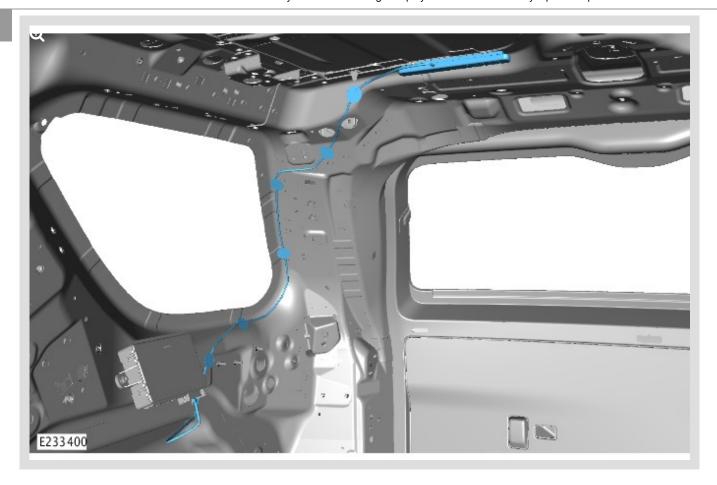
**Discovery:** Coaxial cable wiring harness route.

Route the coaxial cable as shown in the Service Information section above and secure in place with adhesive pads to make sure the cable will remain in its position.

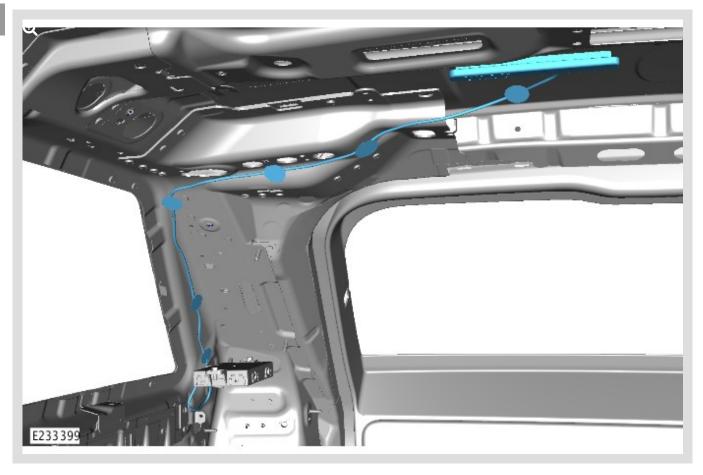
Range Rover Sport: Coaxial cable wiring harness route.

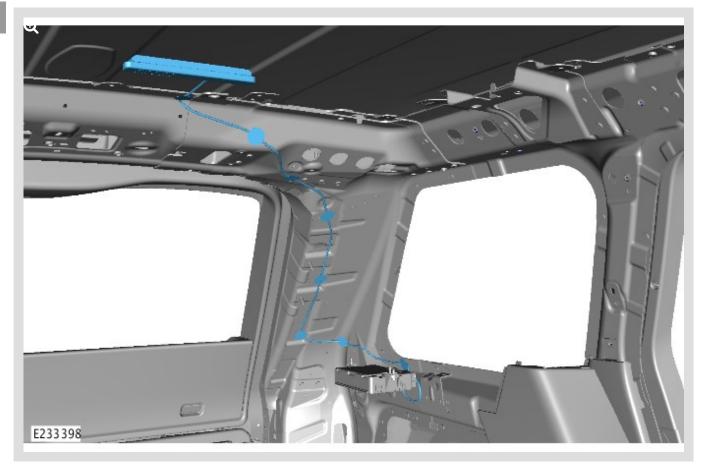
Range Rover: Coaxial cable wiring harness route.

Route the coaxial cable as shown in the Service Information section above and secure in place with adhesive pads to make sure the cable will remain in its position.
